White Paper Report

Grant No. PF-50034-10

Planning for a Sustainable Preservation Environment for Collections

Grantee Institution: Abbe Museum

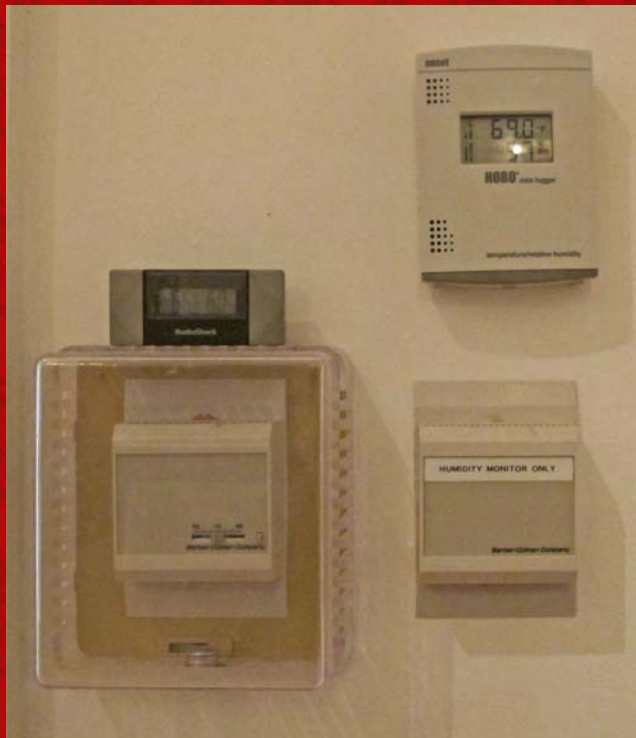
HVAC System Improvements for Improved Efficiency and Reduced Energy Consumption (Electricity and Fuel Oil)

- Improve accuracy, transparency and human interface of HVAC controls system

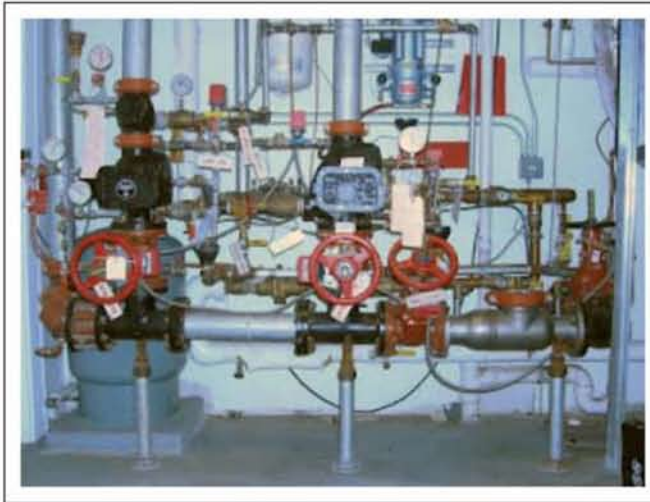
Image 1: The mechanical room of the Abbe Museum. Visitors can learn more about preservation and care of Abbe Collections in the exhibition *Objects of Our Affection*.
